# Safety Inspection Report

Annual Inspection

## Recreation Ground

Alfriston Parish Council

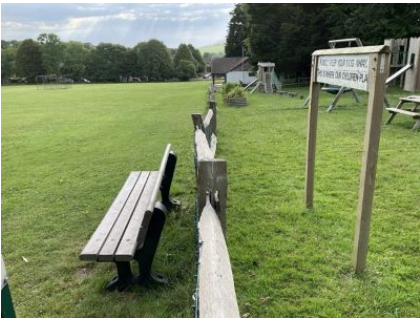
Timber is decayed.

Some posts are decaying below ground level and leaning. Replace any affected posts.  
Monitor regularly for stability.

Replace affected parts.

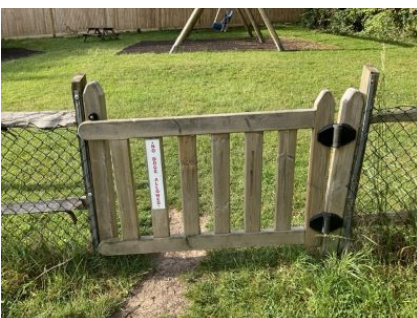
Fixtures loose or missing.

Hinges are loose on top gate, causing gate to drop.

## Tighten.

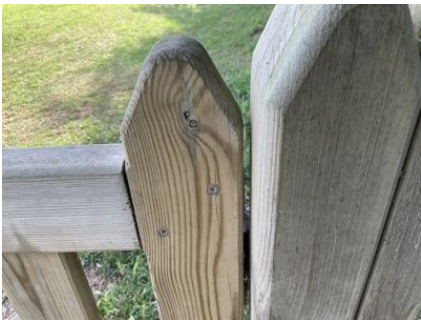
There is a crushing or shearing point on the side of the gate. Where the gaps reduce to less than 12 mm these have been known to cause serious, permanent injury to children, especially on the hinge side where the leverage forces are significant.

Hinge side.

Adjust gate / posts / fit new rubber buffer to ensure a spacing of at least 12 mm throughout the range of the gate to remove the entrapment. The 12 mm gap also should apply on the hinge side of the gate.

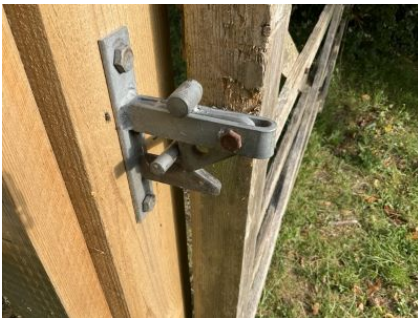
The item is unlocked.

Lock.

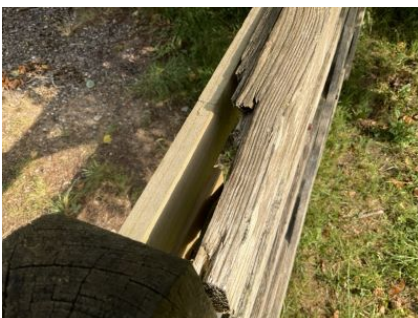
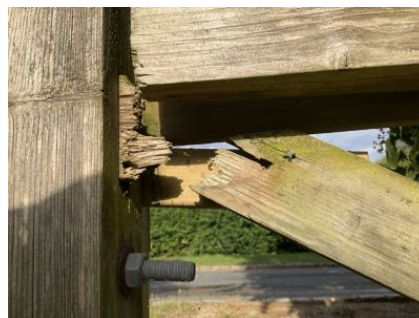
Timber is rotting.

Some timbers are rotting on gate. Monitor and replace accordingly.

Read the notes for further action.

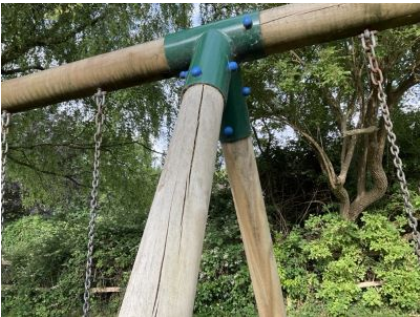
There are natural splits / shakes in the timbers.

DO NOT fill shakes. There are shakes running through fixing points. Ensure the fixings are fully secure on regular basis.

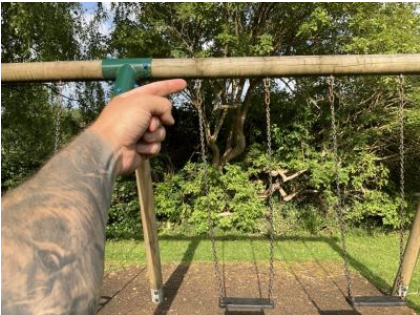
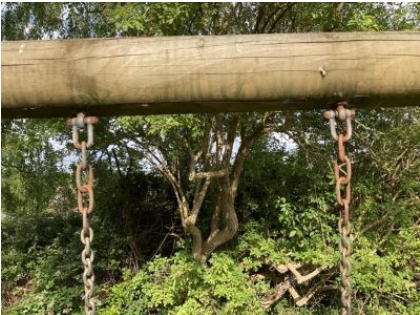
Additional comments are noted below.

Hanger x1 is at a slight angle. Straighten up.

Repair.

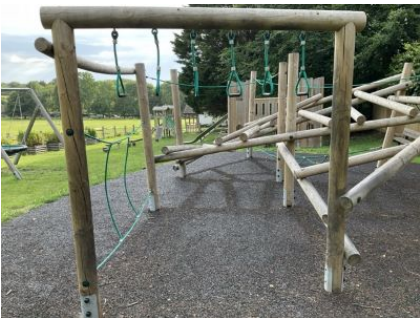
Overhead ladders and rings provide significant play value and benefits to children, and with it the risk of falling. Ensuring the surface remains in good condition will help to keep the correct balance between benefits and risk.

The protective surface under all bars and rings must be kept in good condition.

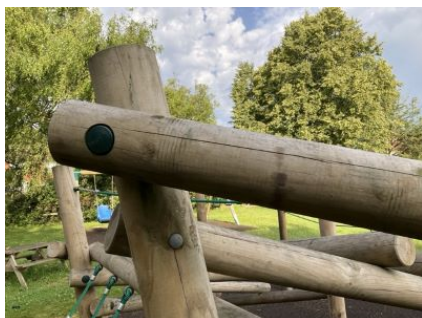
There are natural splits / shakes in the timbers.

DO NOT fill shakes. Monitor and sand back any splintered edges as required., DO NOT fill shakes. There are shakes running through fixing points. Ensure the fixings are fully secure on regular basis.

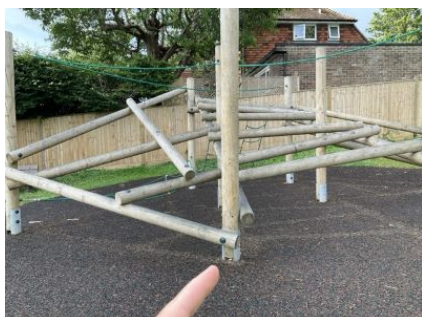
Bolt(s) loose.

Support x1 is loosening in post shoe (central post opposite flower boxes).

Tighten.

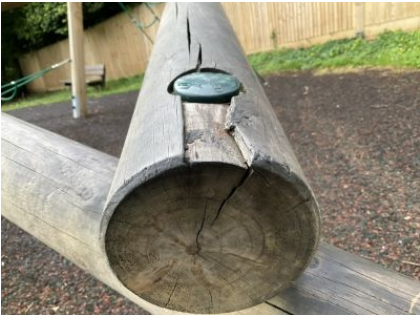
Timber is splintered.

End of beam under overhead rings.

Repair.

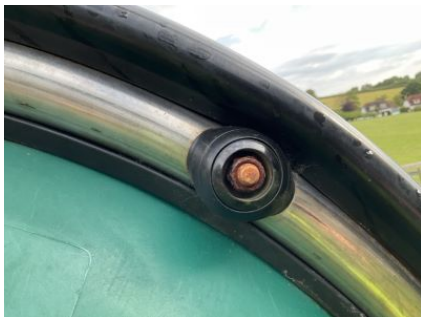
Fittings are rusty.

Nuts under pod.

Replace.

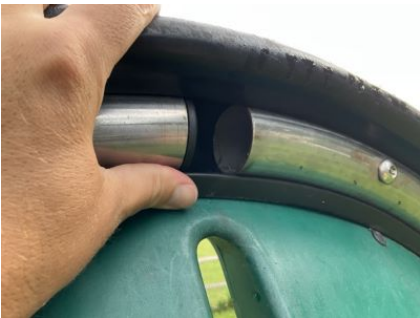
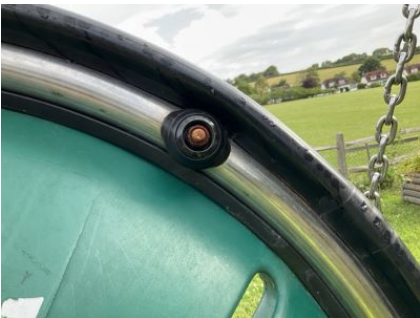
Cap missing.

Replace.

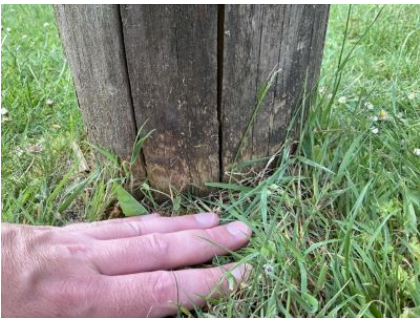
Strimmer damage is present on posts, allowing water to enter and timbers to soften. It can also remove the protective envelope around the timber. Prevent further damage and check timbers for decay throughout the year.

Damage from strimmers and potentially collisions with lawn mowers.

Prevent further damage.

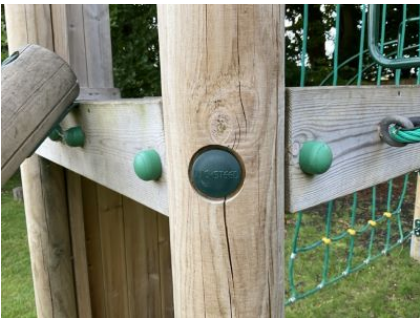
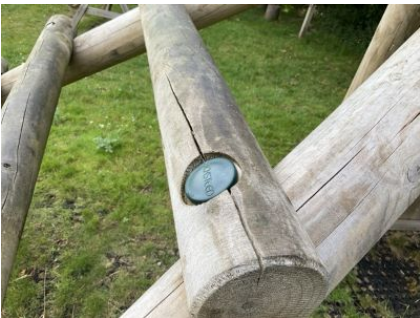
There are natural splits / shakes in the timbers.

DO NOT fill shakes. Monitor and sand back any splintered edges as required., DO NOT fill shakes. There are shakes running through fixing points. Ensure the fixings are fully secure on regular basis.

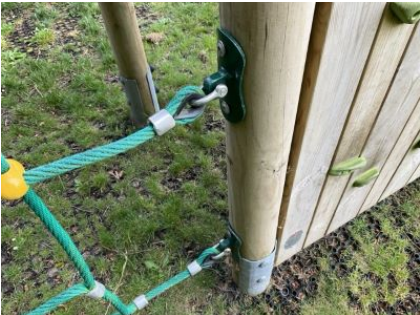
Fixtures loose or missing.

Netting fittings to supports are loosening. Tighten.

Tighten.

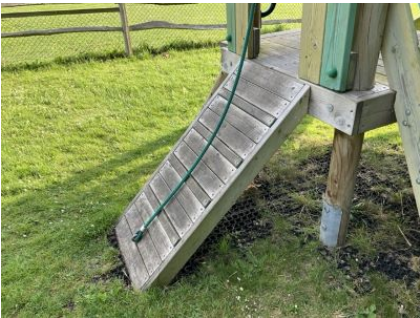
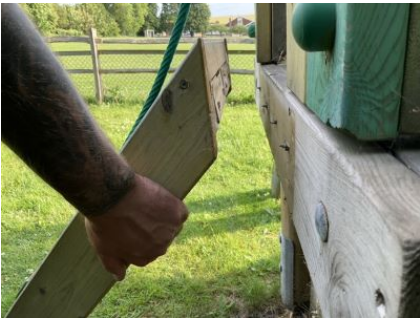
Moderate repairs are needed.

Ramp is not secured to platform.

Repair.

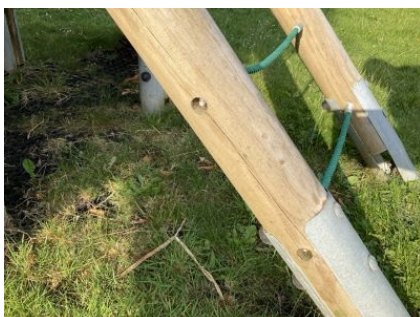
Cap missing.

Replace.

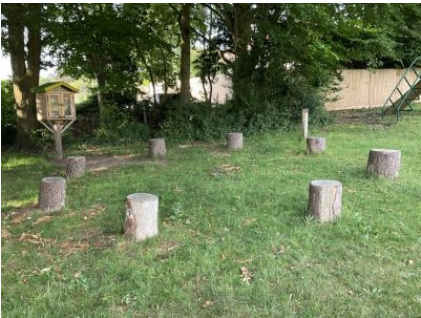
Loose in ground.

Logs are loose in ground.

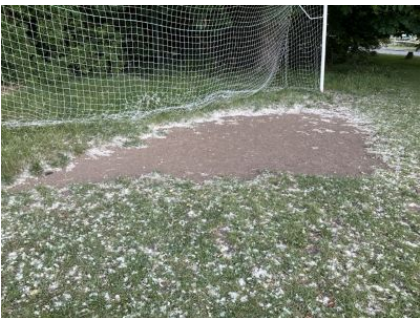
Surface is wearing.

Monitor for significant deterioration and rectify when necessary.

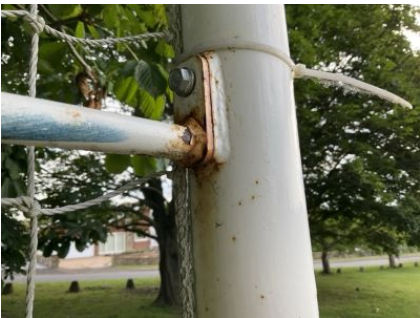
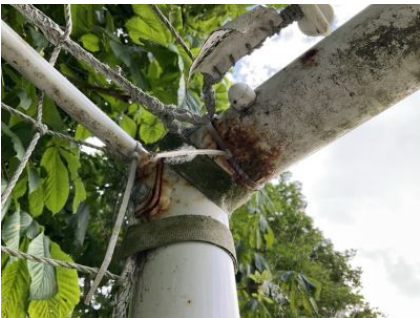
Paintwork is in poor condition.

De-scale back to good base material and coat with lead free paint, using appropriate precautions. Repairs may be necessary where corrosion is severe.
