# Safety Inspection Report

Annual Inspection

## Recreation Ground

Alfriston Parish Council

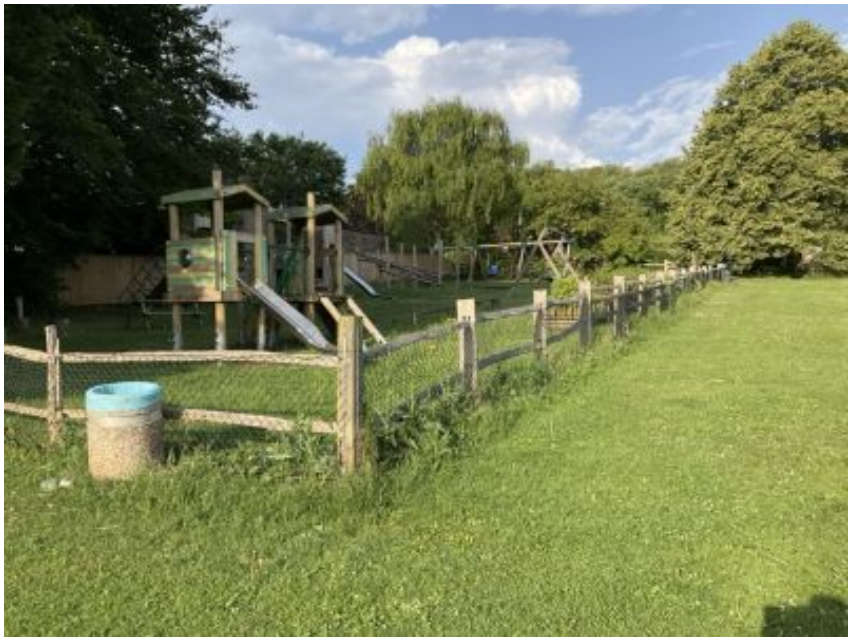
# Fencing

Timber is decayed.

Some posts are decaying below ground level and leaning. Replace any affected posts.  
Monitor regularly for stability.

Replace affected parts.

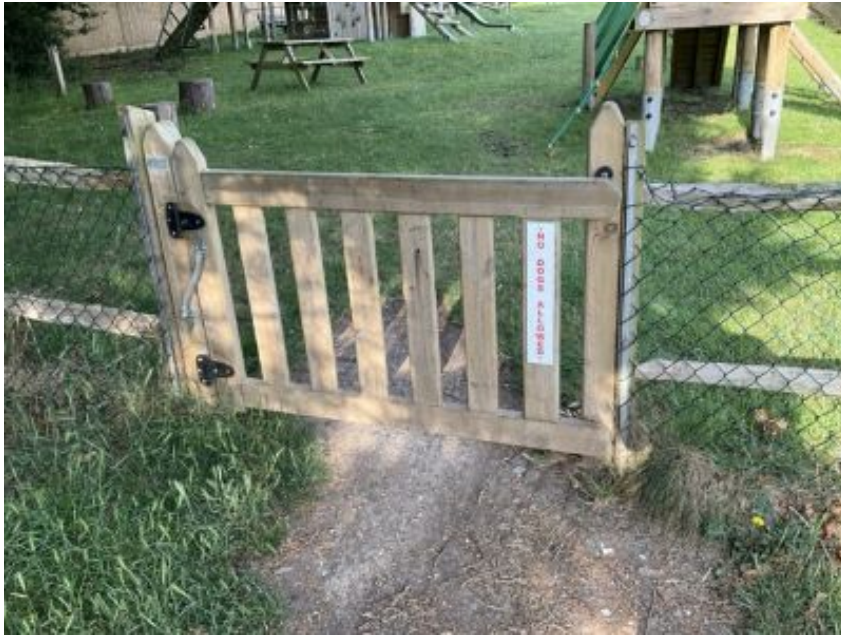
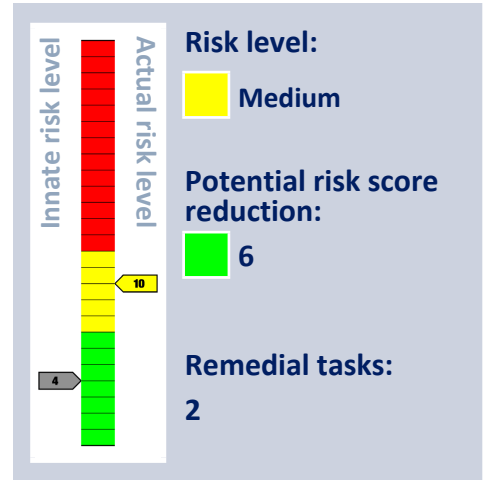
## Gates - Pedestrian

Fixtures loose or missing.

Hinges are loose on top gate, causing gate to drop.

There is a crushing or shearing point on the side of the gate. Where the gaps reduce to less than 12 mm these have been known to cause serious, permanent injury to children, especially on the hinge side where the leverage forces are significant.

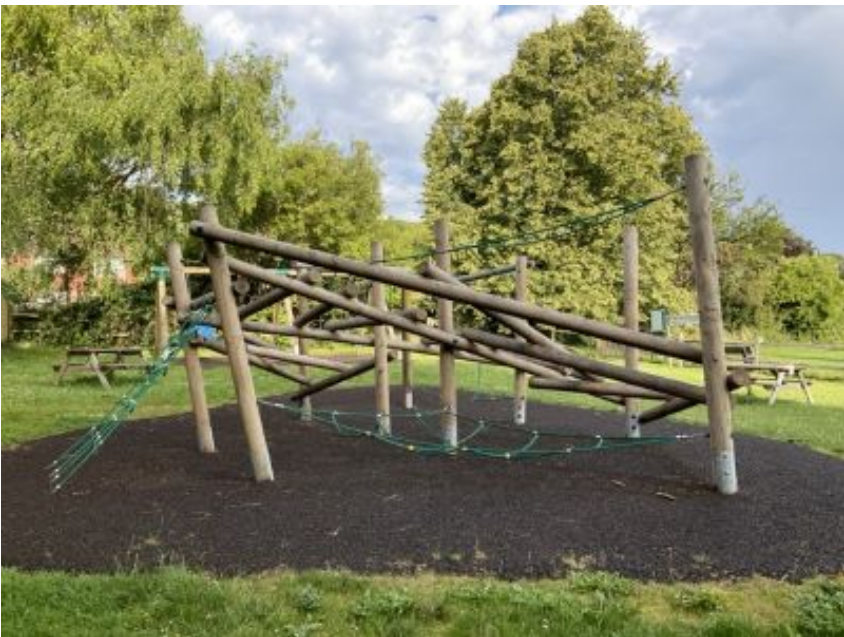
# Climber - Frame & Net

Overhead ladders and rings provide significant play value and benefits to children, and with it the risk of falling. Ensuring the surface remains in good condition will help to keep the correct balance between benefits and risk.

Bolt(s) loose.

Support x1 is loosening in post shoe (central post opposite flower boxes).

The protective surface under all bars and rings must be kept in good condition.

Repair.

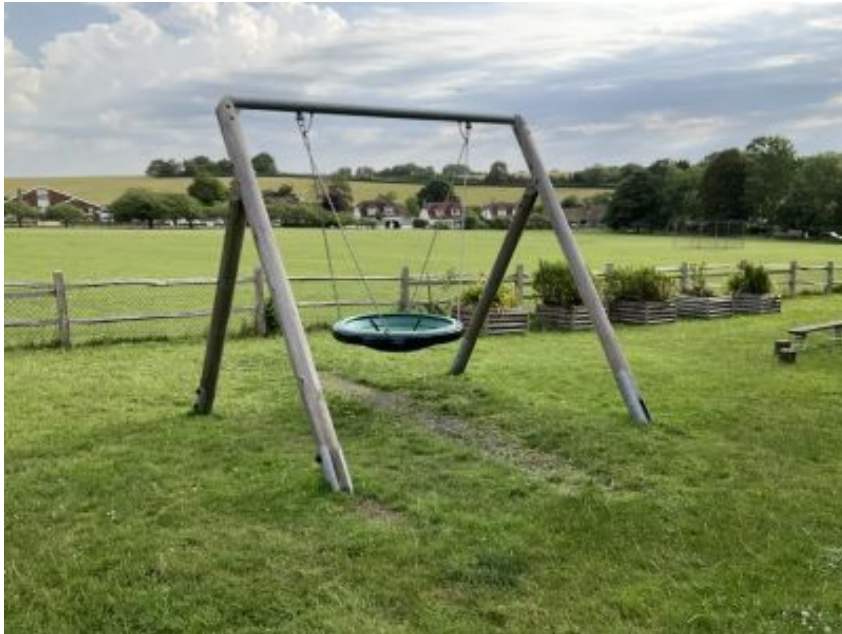
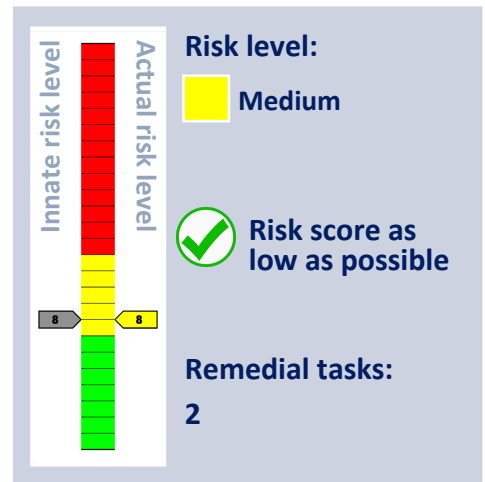
## Swing - Pod Seat

Fittings are rusty.

Cap missing.

Strimmer damage is present on posts, allowing water to enter and timbers to soften. It can also remove the protective envelope around the timber. Prevent further damage and check timbers for decay throughout the year.

Damage from strimmers and potentially collisions with lawn mowers.

Replace.

Prevent further damage.

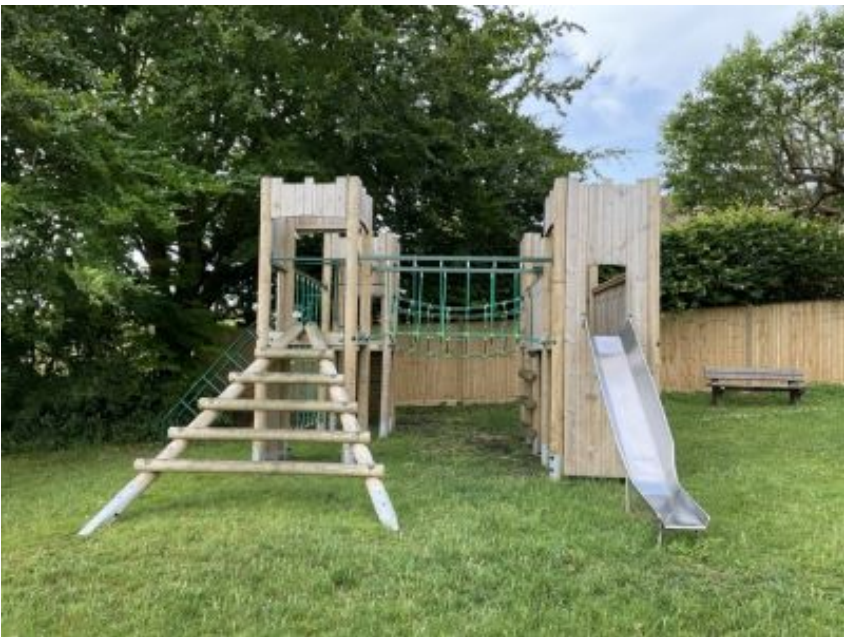
# Multiplay

Fixtures loose or missing.

Netting fittings to supports are loosening. Tighten.

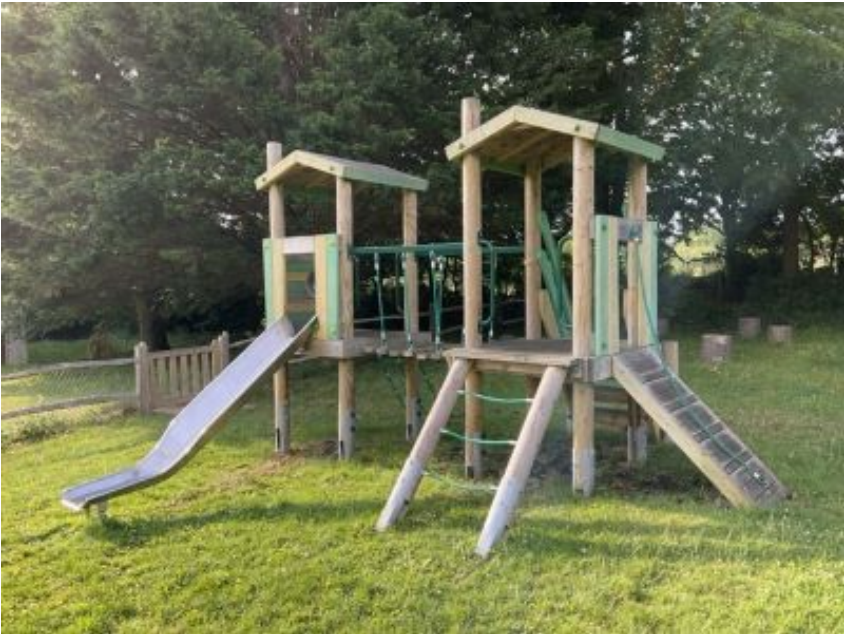
# Multiplay - Toddler

Moderate repairs are needed.

Repair.

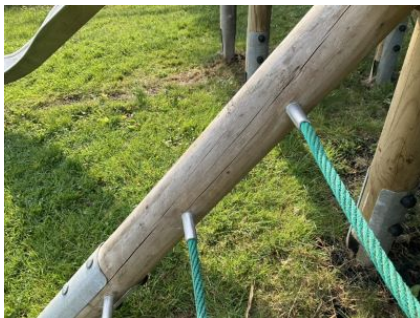
Cap missing.

Replace.

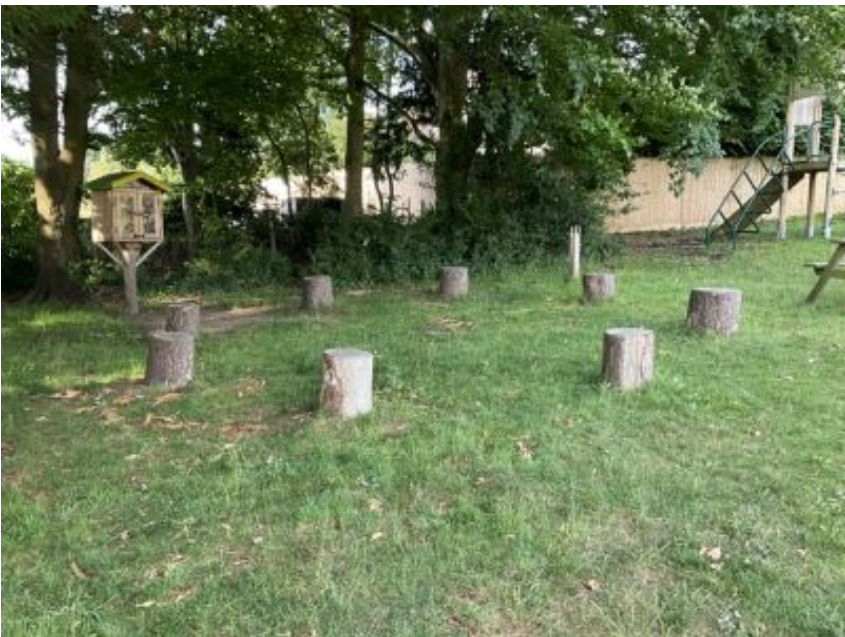
# Play Feature - Story Telling Area

Loose in ground.

Logs are loose in ground.

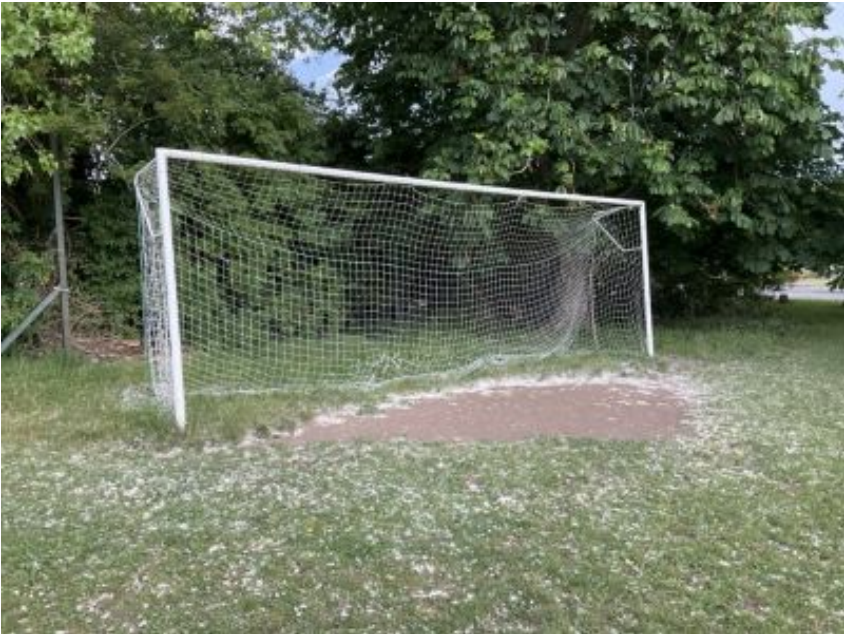
# Goal Post - Football - Full Size

Surface is wearing.

Paintwork is in poor condition.

Monitor for significant deterioration and rectify when necessary.

De-scale back to good base material and coat with lead free paint, using appropriate precautions. Repairs may be necessary where corrosion is severe.
